**NAVAL AIR STATION BERMUDA
FLEET MOORINGS
UNDERWATER INSPECTION REPORT
8-15 JULY 1981**

FPO-1-81(18)
DECEMBER 1981

**OCEAN ENGINEERING
AND CONSTRUCTION PROJECT OFFICE
CHESAPEAKE DIVISION
NAVAL FACILITIES ENGINEERING COMMAND
WASHINGTON, DC 20374**

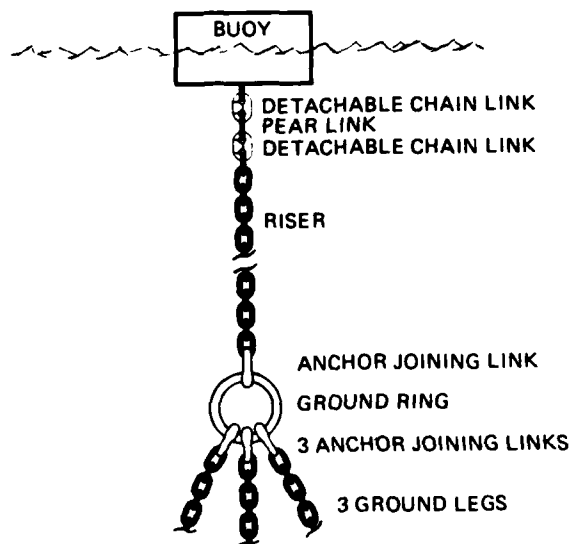
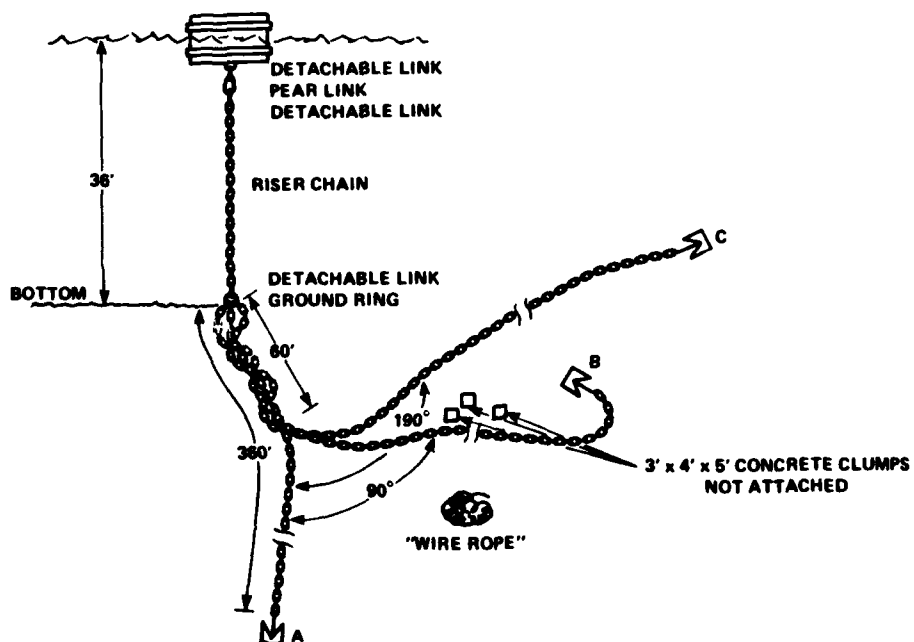
E-1
SCHEMATIC
(NOT TO SCALE)

1.1 Findings. All components of this mooring installation were visible to UCT-1 divers. The buoy was found to be in satisfactory condition, and measurements of the wire diameter at three locations along the riser chain proved to be better than 90% of the specified 1 3/4" size (DM-26). The only shortfall in the riser assembly was the lack of a swivel.

Although the material condition of the ground legs appear to be satisfactory (> 90%), all three legs were intertwined for the first 60 feet from the ground ring, and below this point, all three legs were within a 190° sector of the bottom (see Plan View, page A-1-2). Three 3' x 4' x 5' unattached concrete clumps were located on the bottom between legs B and C, and the anchor for leg B was observed to be backwards (the fluke pointing away from the buoy). Assuming the mooring was correctly installed, it is probable that it was moved under load and apparently dragged legs A and C across leg B.

NOTE: ONE SWIVEL ON EACH OF LEGS A AND B FIVE FEET BELOW THE GROUND RING

TWISTED LEGS DUE TO NO SWIVEL IN RISER AND/OR DRAGGING.
LEGS NEED TO BE RE-POSITIONED. GROUND RING UNDERSIZED.

1.2 Conclusion/Recommendation. This mooring is not safe to use and is, therefore, unsatisfactory for fleet utilization. Recommend that the mooring be recovered, inspected, and overhauled as required.

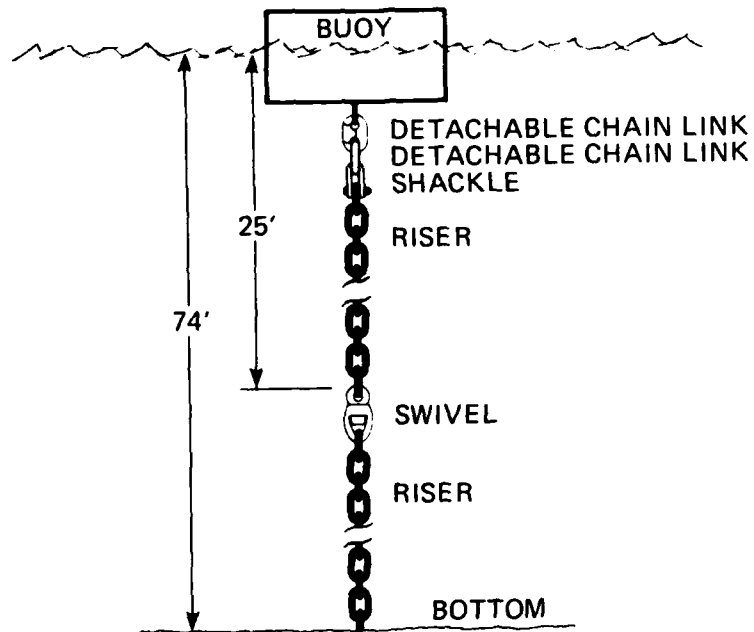
E-2
SCHEMATIC
(NOT TO SCALE)

1.1 Findings. This mooring is located in 72 feet of water, and only the buoy and riser chain were visible to the divers. The ground ring, ground legs, and anchors were all buried in the silt/mud bottom, and their material condition and the orientation of the three legs could not be determined. Although the buoy was in satisfactory condition, the riser chain was in unsatisfactory condition. Single link measurements near the tidal wear point revealed that some links were worn down to 7/8 of an inch, 50% of their initially designed wire diameter (1 3/4"). Although the orientation of the legs and anchors could not be determined, PWD personnel advised that this mooring may have been dragged off location by a ship.

RISER WORN TO 7/8" (50% REQUIRED DIAMETER)

RECORDS INDICATE MOORING HAS BEEN DRAGGED FROM ORIGINAL
LOCATION AND THAT ANCHORS ARE PROBABLY CLUMPED TOGETHER.

1.2 Conclusion/Recommendation. Due to the unsatisfactory wire diameter of some links in the riser, this mooring is unsafe for fleet use. Recommend that the mooring be completely overhauled.

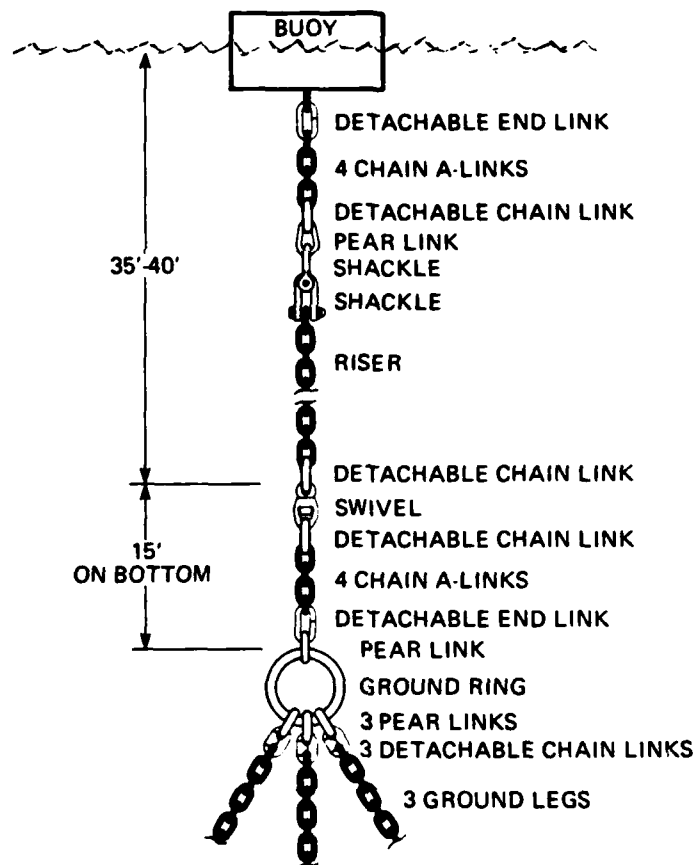
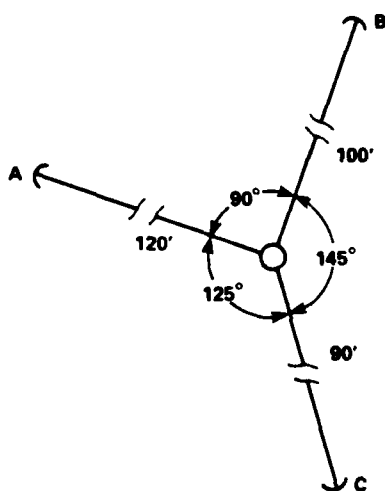
E-3
SCHEMATIC
(NOT TO SCALE)

1.1 Findings. This mooring is in 40 feet of water. The buoy is in satisfactory condition except for being numbered "E-5". The riser is in unsatisfactory condition and badly worn with the wire diameter of some links measuring $\frac{3}{4}$ of an inch, about 43% of their original $1 \frac{3}{4}$ inch diameter. Approximately 15-20 feet of riser chain rests on the bottom with an oversized ($5 \frac{1}{16}$ " wire diameter) ground ring. Between 90' and 120' of the ground legs were visible before they disappeared into the bottom near their anchors, which were visible to the divers. The orientation of these relatively short legs is shown on page A-III-2. The wire diameter of each of the legs was measured to be greater than 90% of its designed diameter of $1 \frac{3}{4}$ inches.

RISER WORN TO 3/4" OR 43% ORIG DIAM, 1 1/4" CHAIN WHEN NEW

1.2 Conclusion/Recommendation. This mooring is unsafe for fleet use and is recommended for complete overhaul.

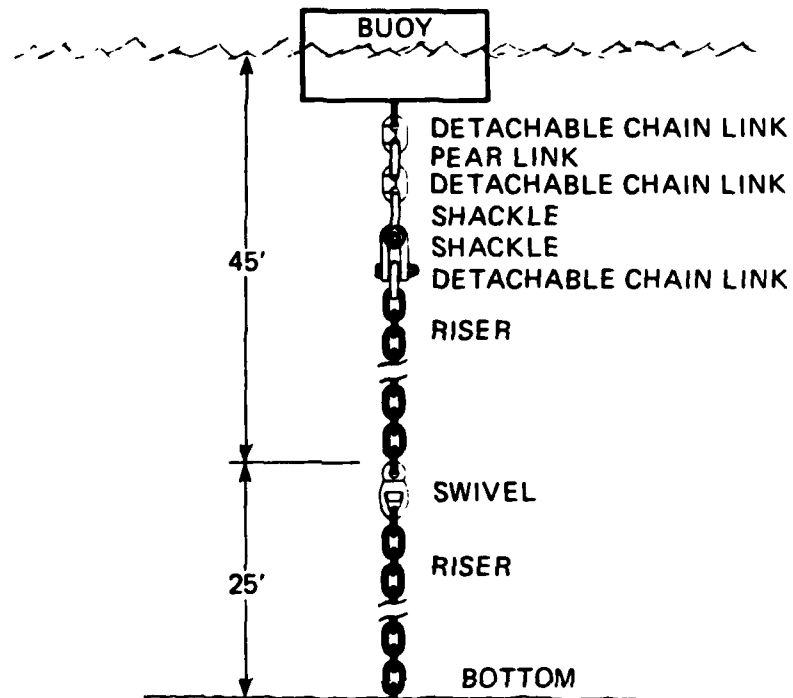
E-4

1.1 Findings. This mooring was originally installed as a Class C mooring and subsequently downgraded twice to a Class E. The buoy's condition is satisfactory, but the connecting jewelry between the buoy and the riser chain is unsatisfactory. Below the buoy, there exists a detachable chain link, a pear link, a detachable chain link, two back-to-back shackles, and a third detachable chain link attached to the riser.

The riser chain wire diameter is greater than 90% of the original oversized 2 1/4 inch diameter chain installed. The riser chain enters the bottom at 70 feet of water depth, and the ground ring, ground legs, and anchors are buried. An attempt was made to raise the ground ring and expose a portion of the ground legs using two one-ton lift bags, but this attempt failed. The condition and orientation of the ground legs were not observed.

CONDITION OF BURIED RING AND LEGS UNKNOWN. LIFT BAGS COULD NOT LIFT
GROUND RING AND LEGS FROM MUD BOTTOM.

1.2 Conclusion/Recommendation. Although the exposed portion of the riser chain shows little sign of corrosion or wear, the condition of the buried portion of the mooring is unknown. This mooring should be removed, inspected, and overhauled as required. Until this is accomplished, the degree of safety available to fleet units utilizing this mooring is uncertain.

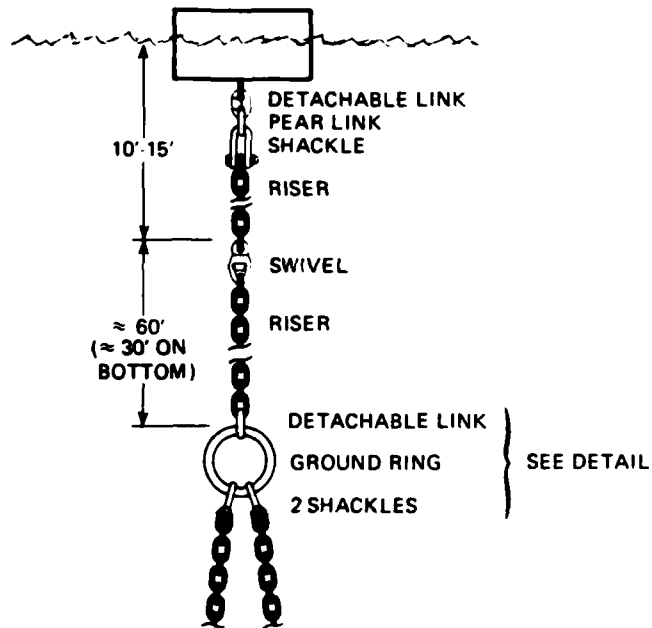
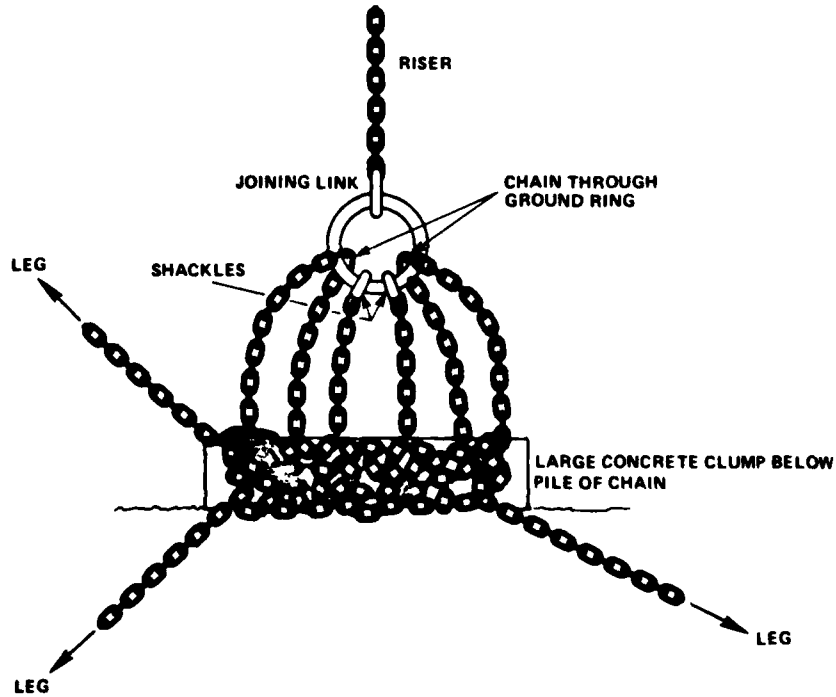
E-5

1.1 Findings. This mooring is installed in 35 feet of water depth. The condition of the buoy is satisfactory, but the riser chain is excessively worn with wire diameter sizes as small as 7/8 of an inch, about 50% of the original wire diameter (1 3/4"). The riser is also too long. Approximately 30' of riser chain is stretched out on the bottom leading to the ground ring. The ground ring was on the bottom and was determined to be in satisfactory condition. However, shackles connect only two ground legs to it, and two lengths of chain run through the ground ring (see sketch on page A-18). These two lengths of chain and the two identified ground legs lead to a nearby mound of entwined chain atop and alongside a large concrete clump. From this entwined chain, three legs were observed to run out approximately 100 feet each to their anchors. The bitter end of the leg not connected to the ground ring was not observed nor was it determined whether the concrete clump was attached to one or more of the ground legs. The reason for the chain lengths passing through the ground ring is unknown. In addition, the wire diameters of all three ground legs are less than 90% of original diameter.

ITEM	SIZE	LOCATION OF MEASUREMENT	CONDITION		REMARKS
			SAT	UNSAT	
SUMMARY:					
Unsatisfactory condition. Worn/deteriorated riser chain, one ground leg not connected to ground ring;					
ground legs too short; two lengths of chain loop through ground ring; ball of chain near ground ring atop					
and alongside large concrete clump.

1.2 Conclusion/Recommendation. This mooring is unsafe for use and is recommended for overhaul.

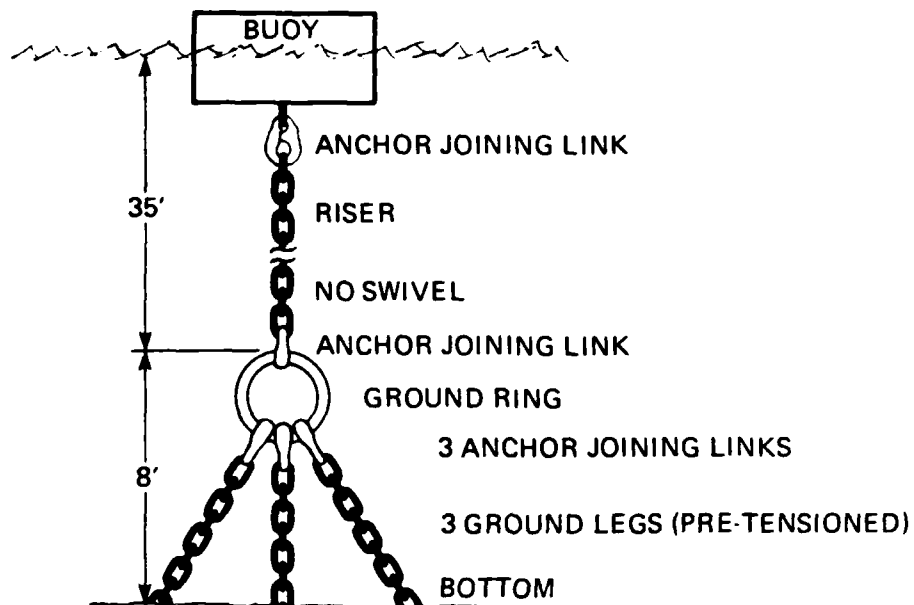
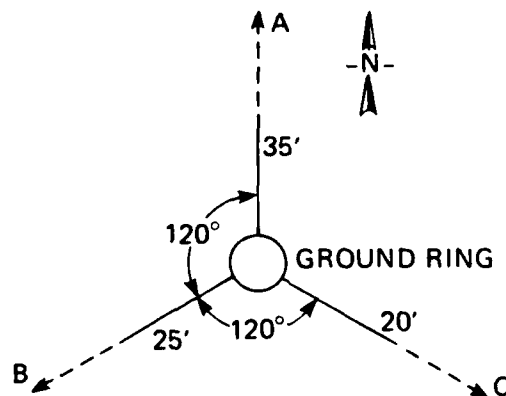
F-1

1.1 Findings. Although DM-26 requires only 1 1/4 inch chain for a Class F mooring, the riser and legs of this mooring consist of 1 3/4 inch chain. The condition of the buoy and riser is satisfactory and the ground ring is about 8-10 feet above the bottom. The ground ring was fabricated locally and is of non-standard size (8" inner diameter). Although smaller than the design requirements of DM-26, records indicate that this ring was pull tested to 50K pounds prior to installation and is, therefore, considered satisfactory for an "F" class mooring. This ground ring is made of tempered steel, and (although none was observed during this inspection) corrosion should be anticipated due to the differences in the relative galvanic potential of steels of different compositions. The condition of the 20-35 feet of pre-tensioned ground legs exposed appears to be satisfactory as is the leg orientation. The only deficiency noted was the lack of a swivel in the riser chain.

NOTE: SWIVEL IN LEG B, 12'
OUT FROM GROUND
RING

SATISFACTORY BUT NEED SWIVEL IN RISER WHEN OVERHAULED

1.2 Conclusion/Recommendation. This mooring conditionally meets the required criteria for a Class F mooring, but a swivel should be inserted in the riser chain.

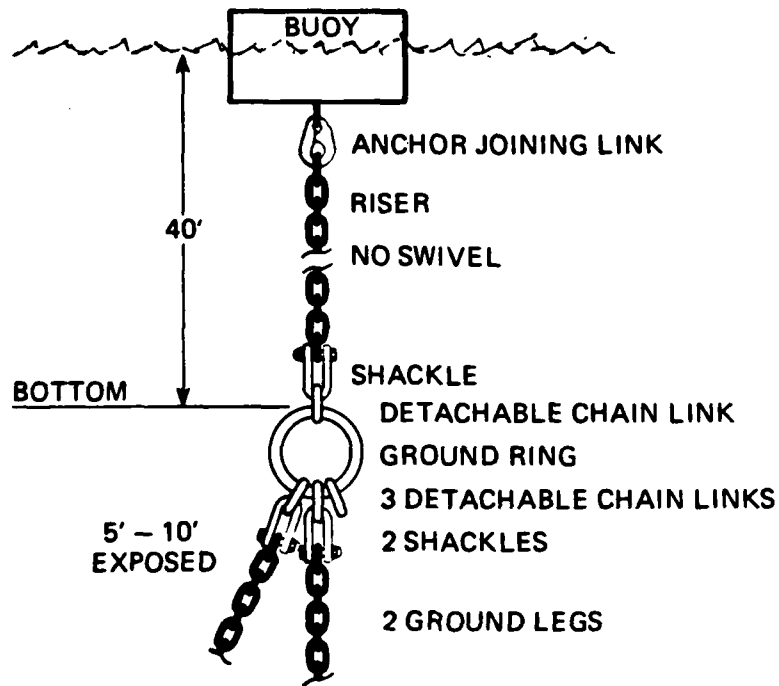
F-2
SCHEMATIC (NOT TO SCALE)

1.1 Findings. This mooring is installed in 40 feet of water. The condition of the buoy is satisfactory, but the riser chain shows signs of wear and corrosion. The wire diameter of the riser is less than 90% of its original diameter (1 3/4"), but since a Class F mooring only requires 1 1/4 inch chain, the condition of the riser is satisfactory. No swivel exists within the riser chain.

The ground ring is on the bottom attached to two ground legs by shackles. The third ground leg was not located and assumed to be buried in the bottom. Although the wire diameters of the two observed 1 1/4 inch ground legs were satisfactory, only 5-10 feet of these legs were exposed prior to entering the bottom. The length and orientation of these legs are unknown.

MISSING LEG

1.2 Conclusion/Recommendation. This mooring is unsatisfactory for fleet use and is recommended for overhaul.

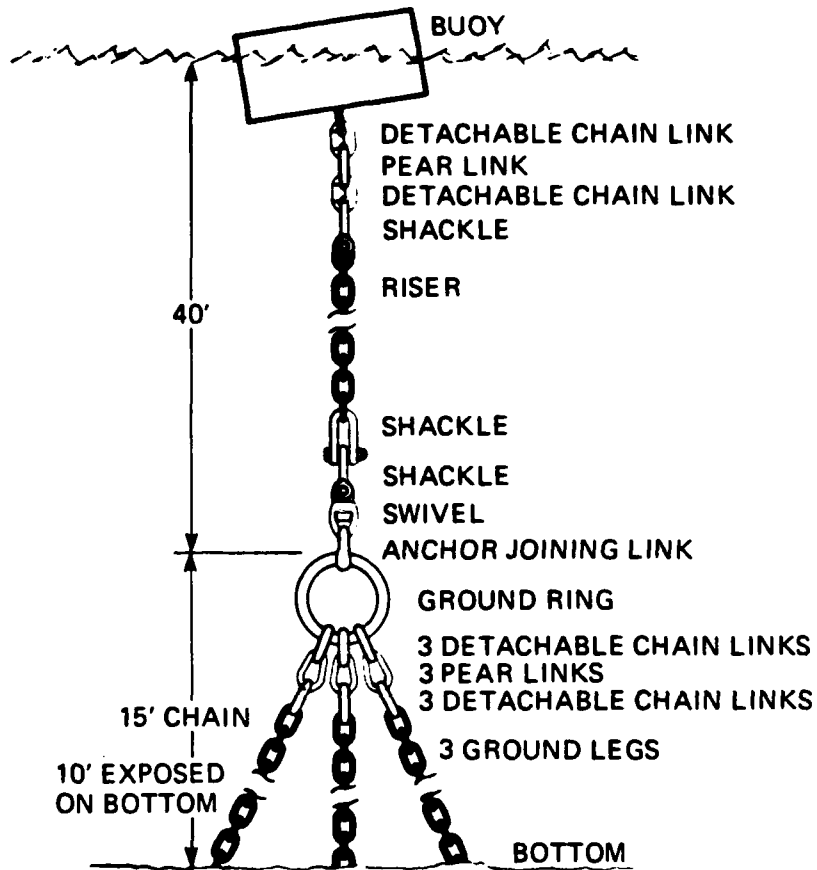
F-3
SCHEMATIC (NOT TO SCALE)

1.1 Findings. This mooring is in 45 feet of water and was initially installed using 1 1/2 inch chain in the riser and its three legs. Although the exterior condition of the buoy appears satisfactory, its internal integrity is questionable since the buoy has an 8-10 degree trim angle. The condition of the bottom jewelry is non standard, but the condition of the riser appears to be satisfactory. The ground ring is about five feet above the bottom, and about 10-15 feet of each of the three ground legs attached to it are piled on the sea floor beneath it. The wire diameter of each of the three legs measure less than 90%, but greater than 80%, of its original 1 1/2 inch diameter. The remainder of each of the legs are buried and their lengths and orientation are unknown.

8° TO 10° TRIM ANGLE ON BUOY
CONDITION OF BURIED LEGS UNKNOWN

1.2 Conclusion/Recommendation. From a safety standpoint, the use of this mooring by fleet units is questionable. The mooring should be removed, the buoy should be thoroughly inspected in order to determine the cause of its list, and the condition of the ground legs should be determined. The mooring should be overhauled as required prior to reinstallation.

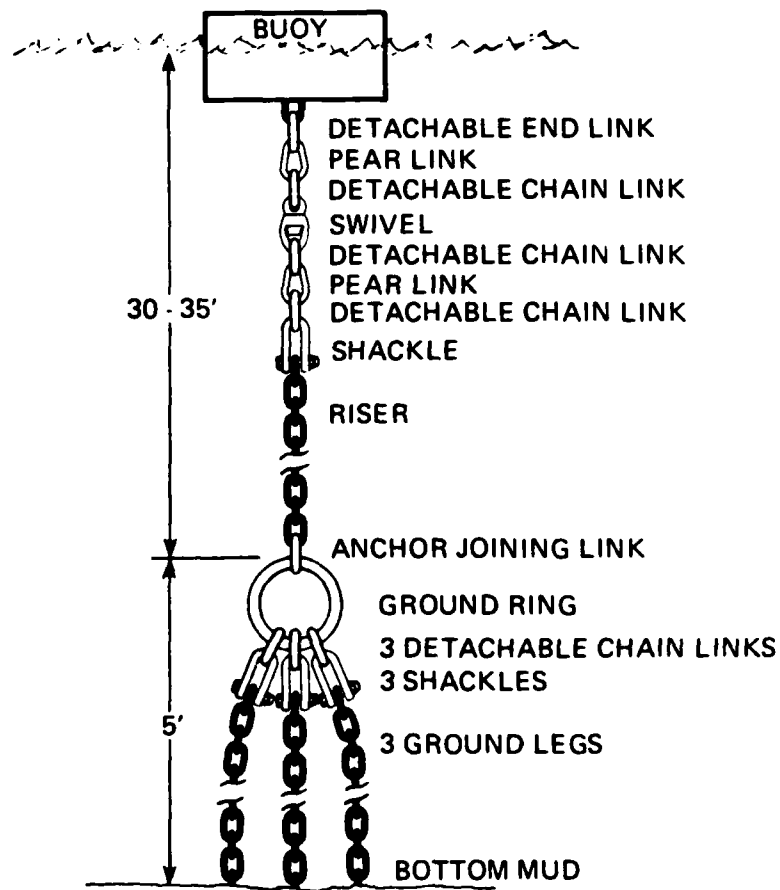
F-4
SCHEMATIC
(NOT TO SCALE)

1.1 Findings. A water depth of 40 feet exists at the mooring site. The buoy's condition is satisfactory, but its bottom jewelry is non standard, consisting of two end links, a swivel, three detachable links and a shackle. The wire diameter of the riser chain is greater than 90% of its original 1 3/4 inch diameter. The ground ring is suspended by the riser about five feet above the sea floor. The three ground legs attached to the ground ring drop parallel into the bottom. The wire diameters of the few feet of each 1 1/2" diameter ground leg observed satisfactorily met the over 90% criteria, but the lengths and orientation of these legs, and the positions of their anchors are unknown.

LEG ORIENTATION AND CONDITION BELOW BOTTOM UNKNOWN

1.2 Conclusion/Recommendation. This mooring should be used with caution due to the uncertainty concerning the positions and conditions of its ground legs. Recommend that this mooring be recovered, inspected, and overhauled as required.

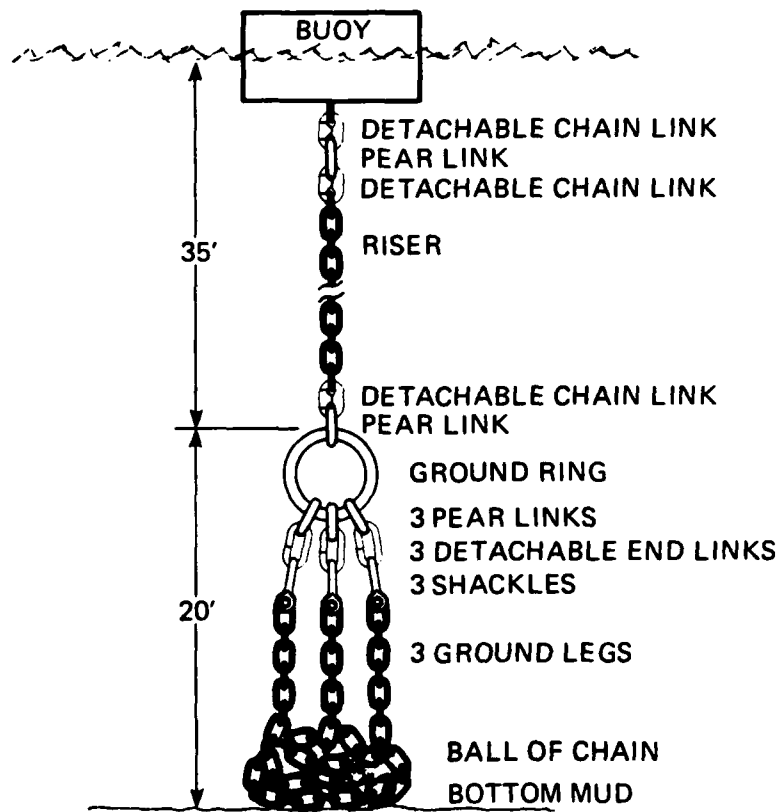
F-6
SCHEMATIC
(NOT TO SCALE)

1.1 Findings. As with most other moorings, the condition of this buoy is satisfactory. The riser chain wire diameter meets acceptable standards, but the riser does not contain a swivel. In addition, the riser is too short. The water depth at the site is 55 feet. The ground ring is approximately 20 feet above the bottom. The three ground legs attached to the ground ring drop parallel to the bottom where a pile of intertwined chain exists. The three chain legs apparently enter the mud bottom from under this pile of chain.

The twenty plus feet of each ground leg exposed below the ground ring are heavily corroded and pitted. Two of the three ground legs failed the 80% wire diameter measurement test.

NOTE: 5' OF EACH LEG IN BALL AT FLOOR

GROUND LEGS WORN TO BELOW 80% OF REQUIRED 1 1/4" WIRE DIAMETER
AREA LESS THAN 65% OF THAT REQUIRED

1.2 Conclusion/Recommendation. This mooring is unsatisfactory for fleet use and is recommended for complete overhaul.

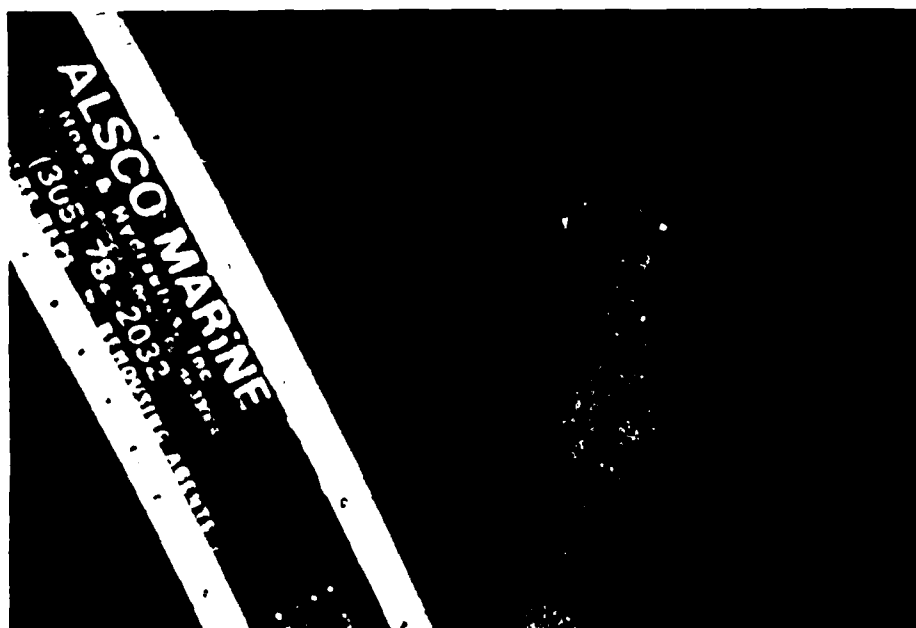
Figure C-2. Deteriorated Section of Mooring E-5 Riser Chain

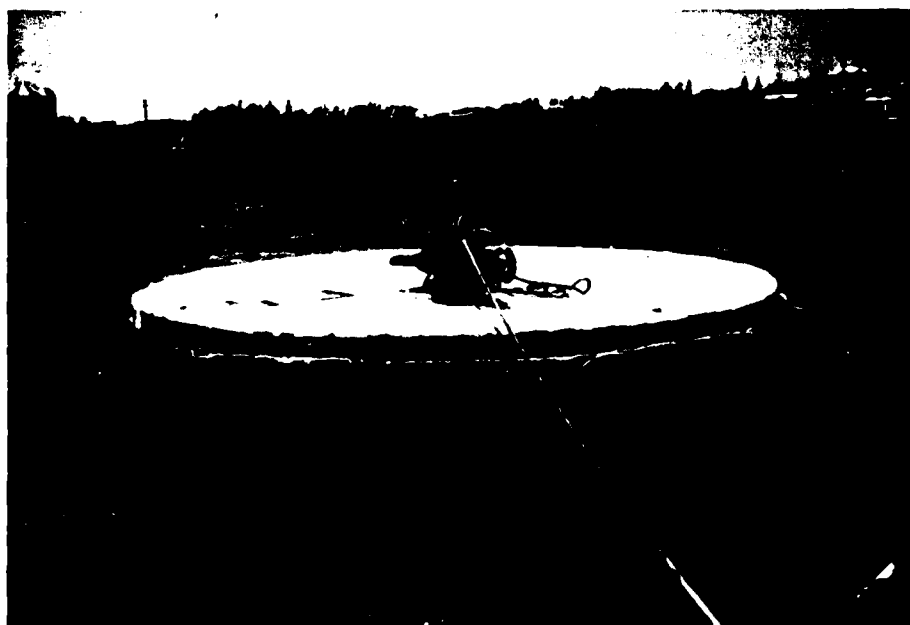
Figure C-4. Buoy F-4 - A Sample of the Typical Buoy Condition
